# THE BUILDINGS OF MOREFA BORTH

## RICHMOND Morfa Borth

A detached house on the beach side in the middle of Borth High Street. House of a master mariner by 1871. Built after 1848 and before 1871.

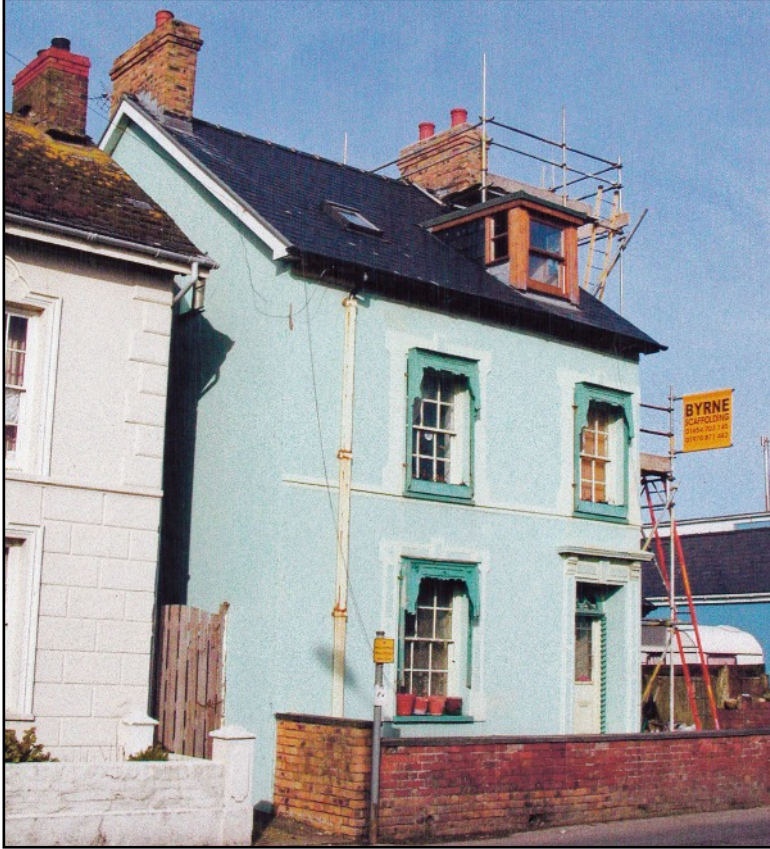
*Richmond in 2009 - it was having a chimney repaired.*

Richmond is a generously tall, two storey, single fronted detached house with a dormer window and roof lights for an attic floor. The house is under a gable roof parallel with the street. There is a brick chimney each end of the roof with room for two chimney pots.

The walls are rubble stone and rendered. This house is unique, the spacing of its doors and windows are not related to those of Tyrol House next door. The front door is close to the edge of the building allowing plenty of room for a decent sized living room alongside a hall. There is a single storey porch on the north side of the building under a gable roof with a back

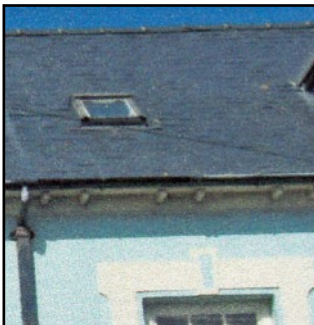
door, and this is beside a drive with room to park a car and beyond gates lead into the yard, and to an outbuilding. A brick wall encloses the front garden.

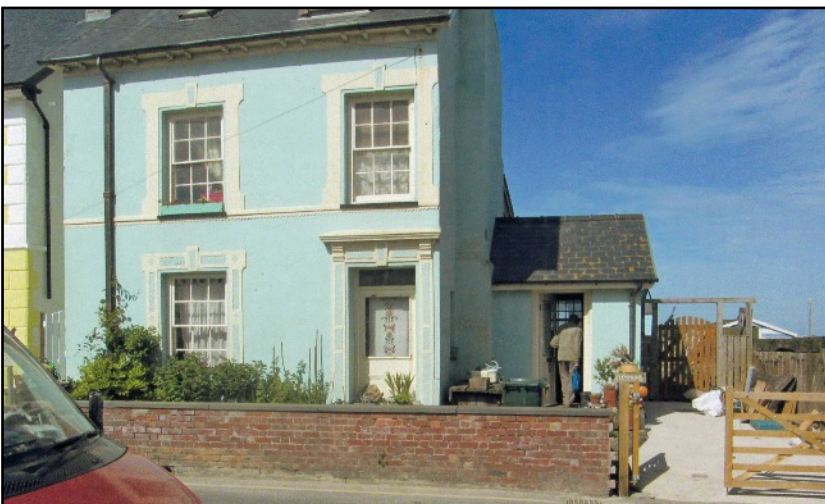
*LEFT Pairs of dentils (brackets) support the overhanging roof. Houses in the tall terrace at the north end of the High Street dating just after 1859 such as Bradford House also have these.*

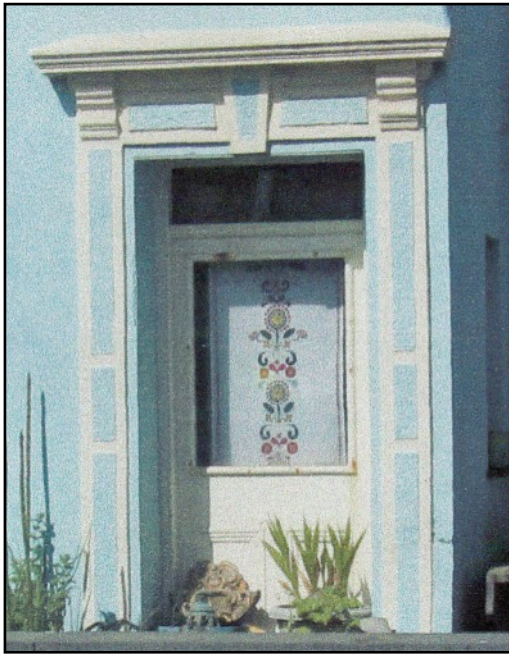
*BELOW The decorative rendering on the front of the house is divided into two by a string course (line of moulding) beneath the upper window. Unlike Tyrol House next door which has a rusticated masonry pattern below, the rendering on Richmond today is smooth both above and below this. The windows have shaped frames with a keystone.*

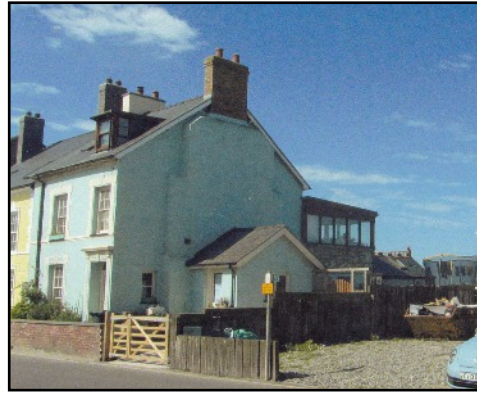
*LEFT* A detail of the rendered decoration around the former front door which is topped by a cornice supported by brackets. The front door was recessed and today there is a glass panel to light the hall with a decorative blind. *BELOW* The main door is now in a porch at the side.

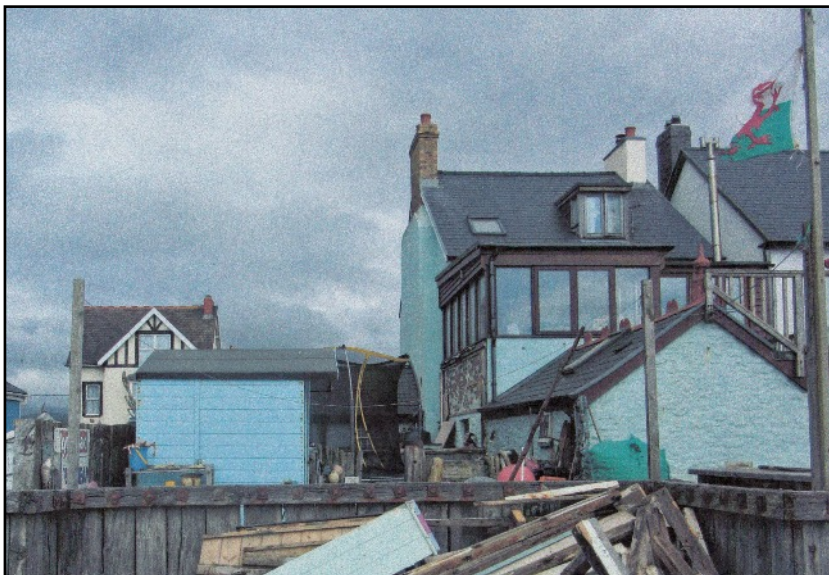
The rear of the house has a two storey extension. Beyond is a single storey section. These were drawn on a map of 1886 and they are rubble stone including rounded stones from the beach. The stone end wall of the extension is plain, no windows or doors to be at risk from stones cast up by the sea in a bad storm. The upper floor of the taller extension is topped by a sun room which opens on to a balcony with fine views of the sea. Below the balcony large windows and a glazed door open into a boarded area of yard. On the north side of the yard is room for an outbuilding. This area of the yard is not as deep, but the defensive fence of sleepers continues around the end of it. The fence has a gateway to the beach at the boarded part of the yard behind the house.

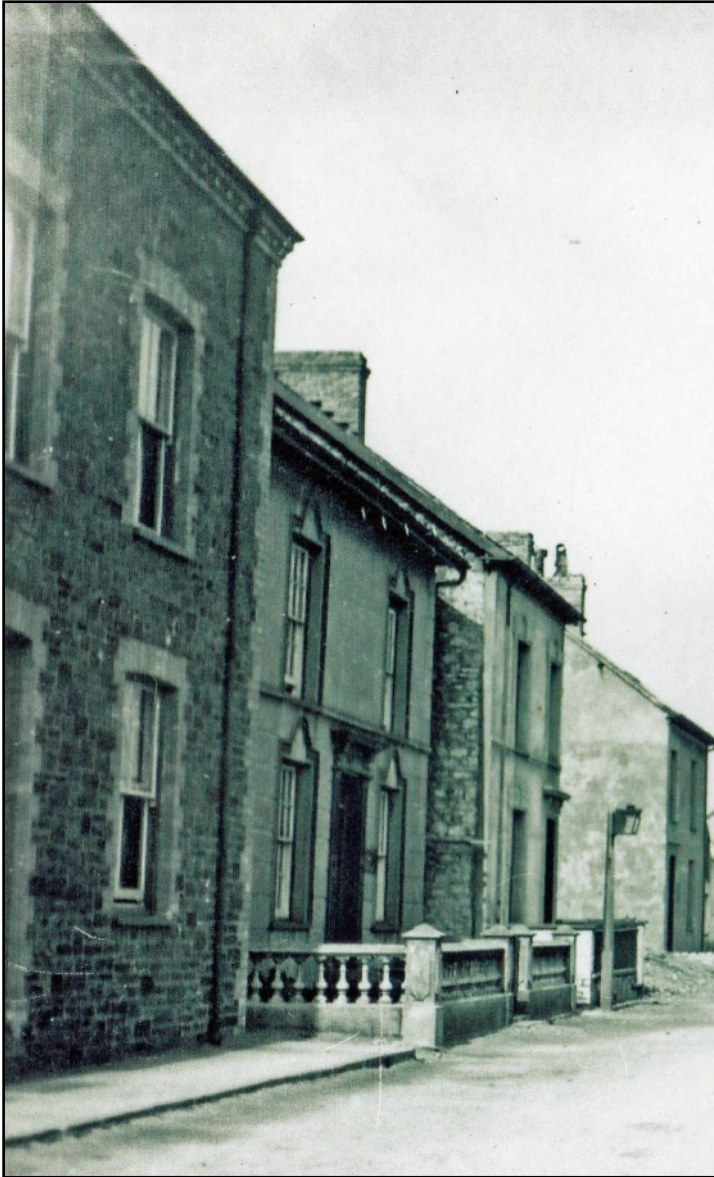
*Richmond is the third house from the left on this old photograph on a glass plate. It had no rendering on its south wall and we can see the rubble stone, and there was no dormer window in the front of the roof. The front garden was enclosed. Outside was a street lamp, probably gas. There was a gasometer close to the railway station at the back of the huge Cambrian Hotel (later Pantyfedwen).*

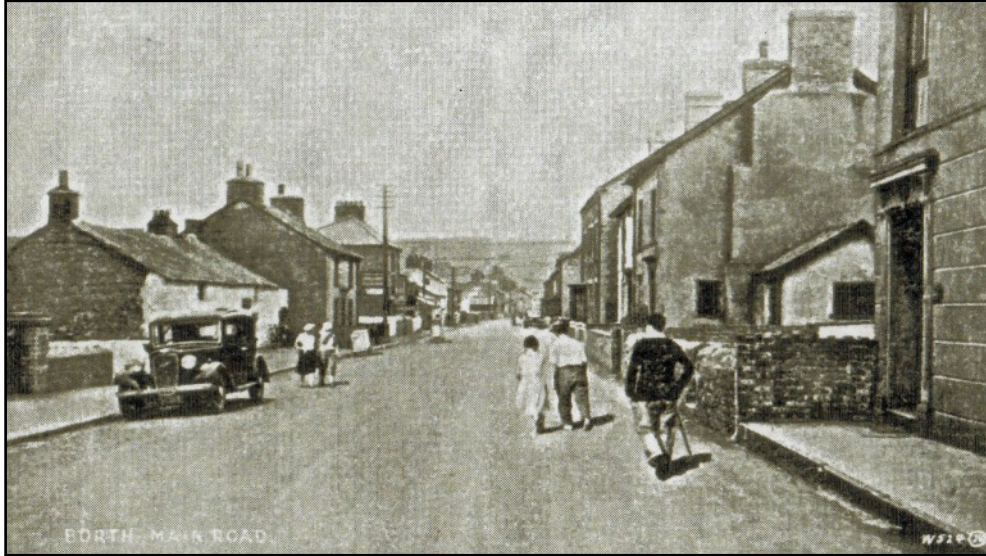
*ABOVE This postcard dated 1936 shows from the right the front door of Ynyswen then Beach Grove, and a walled piece of land alongside and then Richmond which already had its porch and front door at the side but no dormer window.*

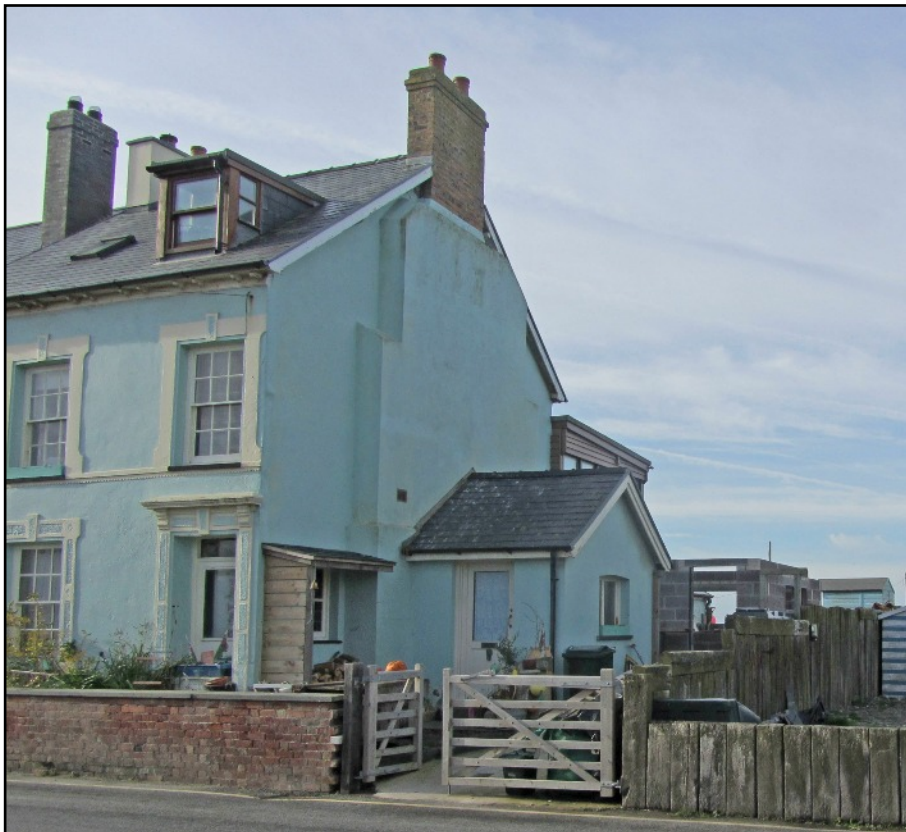
*BELOW In 2016 the side of the house is much the same.*
